2006 Heights Annex Home Inspection

PROPERTY INSPECTION REPORT

Concerning: 2006 Heights Annex Home Inspection
(Address or Other Identification of Inspected Property)

March 7, 2009
(Date)

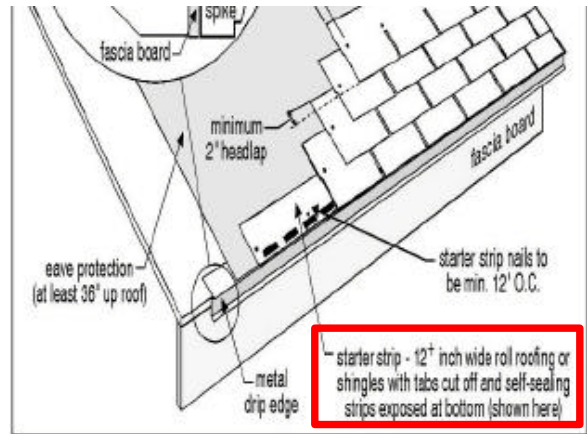
Improper installation of shingle starter course, not installed per manufacture's installation instructions on every bundle of shingle that instructs glue / sealing tabs to be located near lower edge of roofing. When starter course is not installed properly, high winds can peel roofing off. Reference: shingle bundle wrappers. Recommend addition of roof sealant dabs on lower course to mimic / gain effect of properly installed starter course.

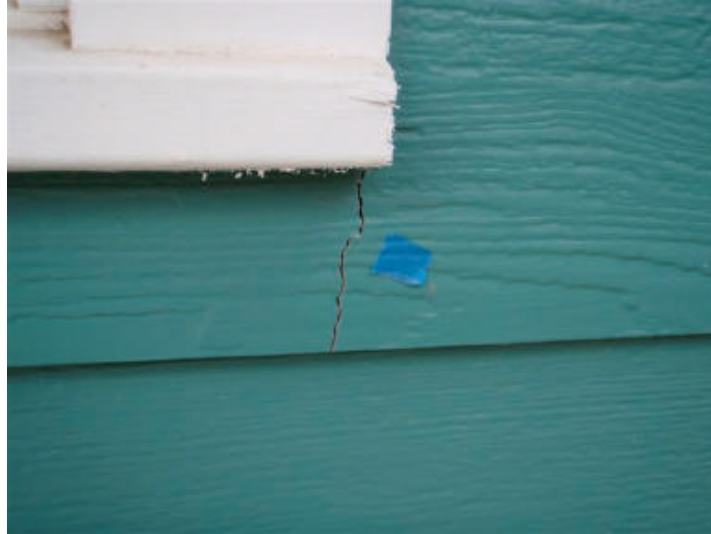
Cracked siding observed at back porch/patio.

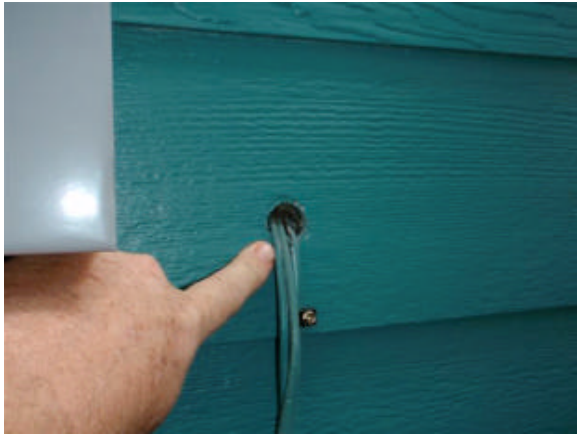
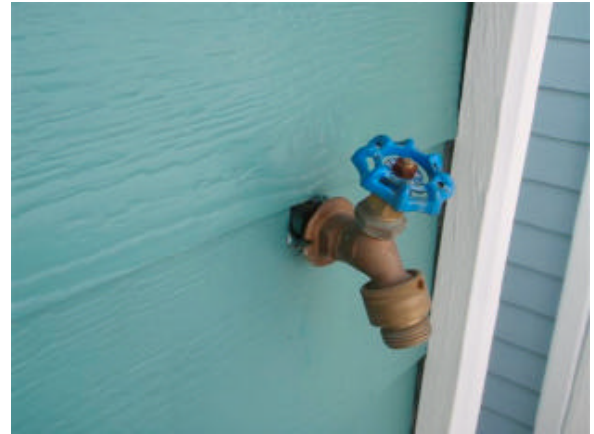
Need sealing / caulking around all holes and exterior siding penetrations on top and both sides, (leave bottom open) to prevent water entry. Including but not limited to dryer, bath and range top vents, light fixtures, etc.
