FIG Services LLC d/b/a FOX INSPECTION GROUP
Property Inspection Report # 090307bg
11227 Endicott Lane Houston, TX 77035
(Office) 713.723-3330 (Email) office@foxinspectiongroup.com

2006 Heights Annex Home Inspection

PROPERTY INSPECTION REPORT

March 7, 2009
(Date)

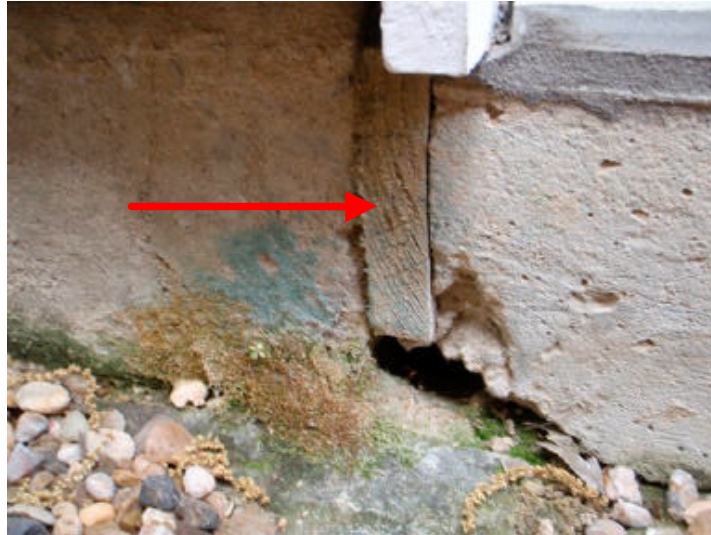
Wood form board(s) around foundation should be removed to reduce chance of wood destroying insect activity. Back of house.

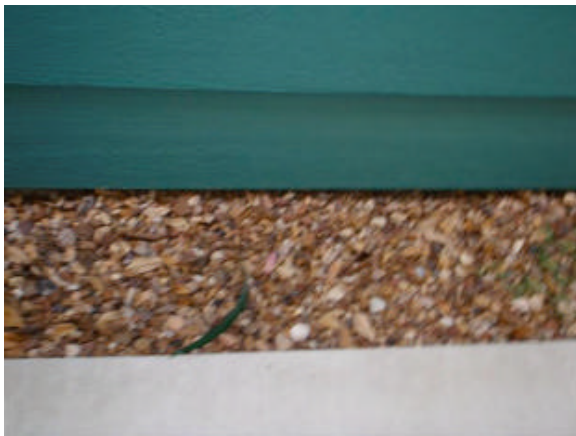
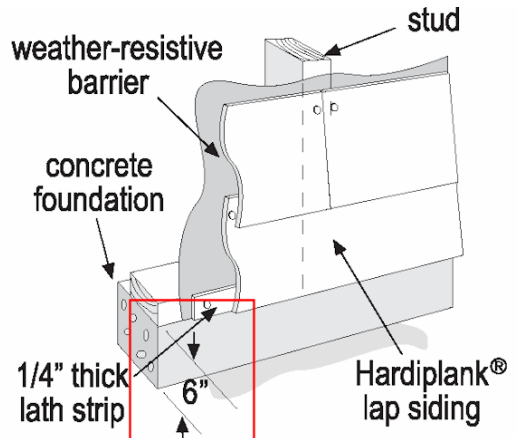
Soil level too high, or close to Hardi plank siding, promotes wood rot and is considered a conducive condition to termite activity at one or more locations around house/garage.

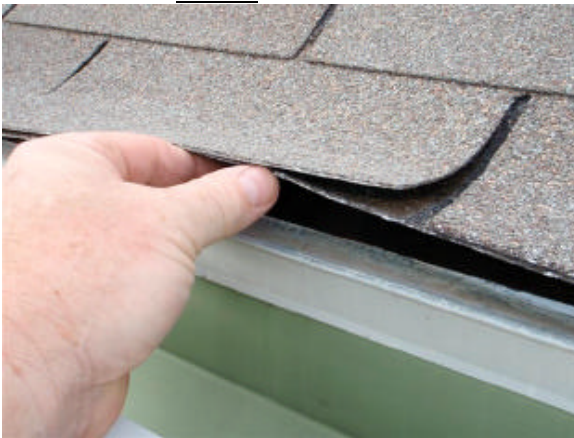
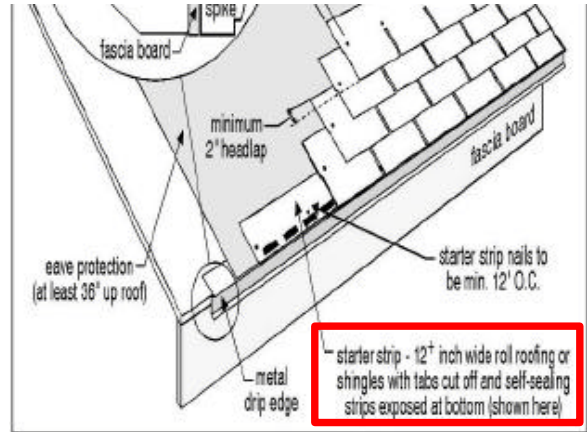
Improper installation of shingle starter course, not installed per manufacture's installation instructions on every bundle of shingle that instructs glue / sealing tabs to be located near lower edge of roofing. When starter course is not installed properly, high winds can peel roofing off. Reference: shingle bundle wrappers. Recommend addition of roof sealant dabs on lower course to mimic / gain effect of properly installed starter course.

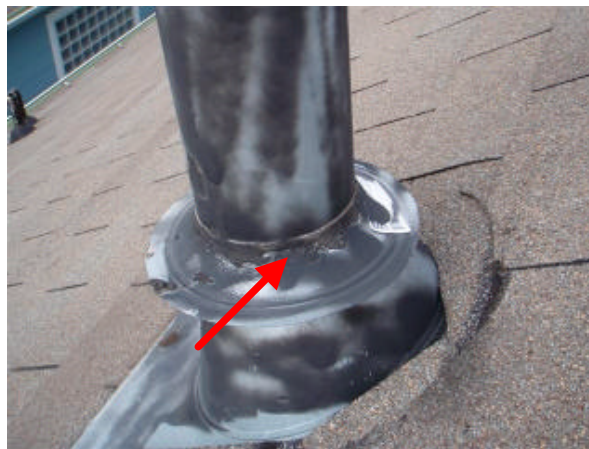
Storm collar needs caulking on all house and water heater vent pipes.

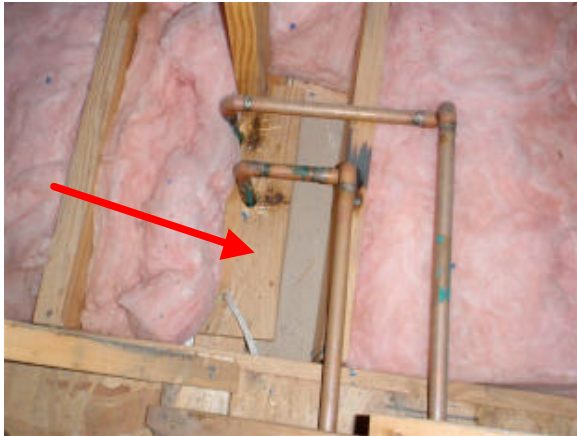
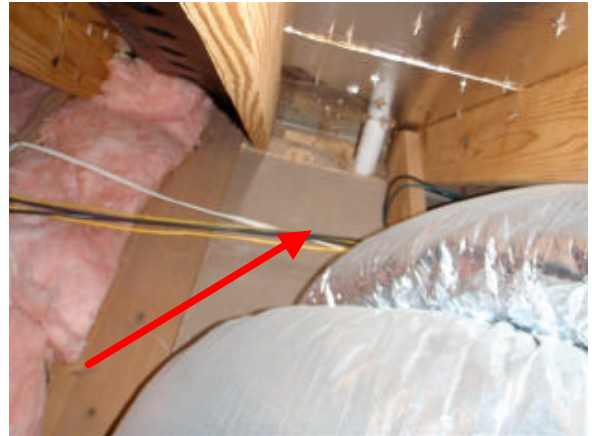
Insulation not properly positioned/missing in areas, etc.

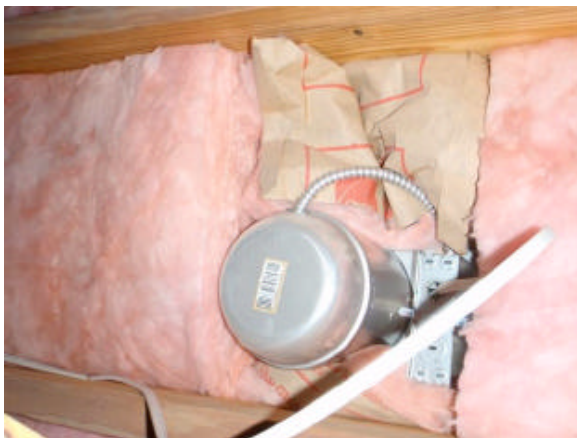
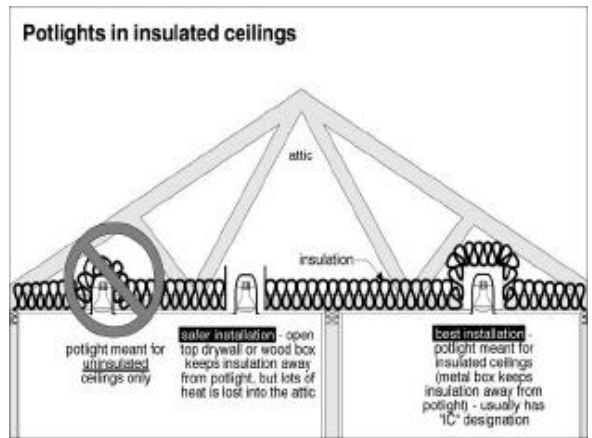
Ensure insulation is maintained a minimum of 3 inches and wood a minimum of 1 inch from around all recessed lights to reduce possible fire hazard.

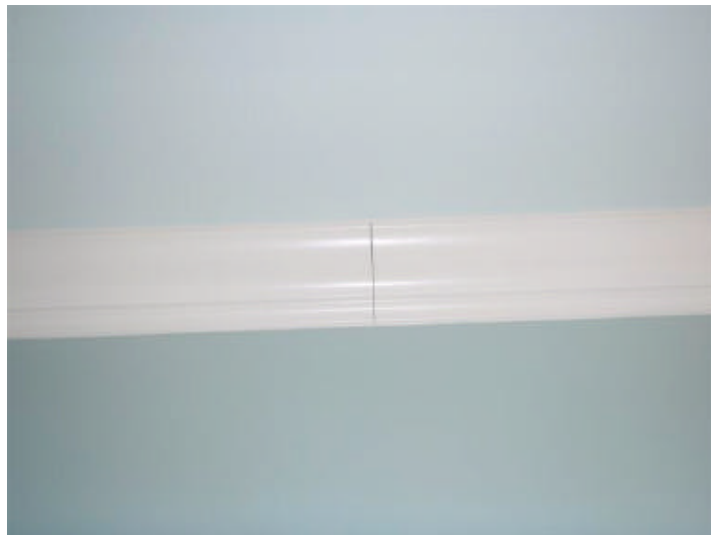
Crown molding separated in 2nd floor bedroom.

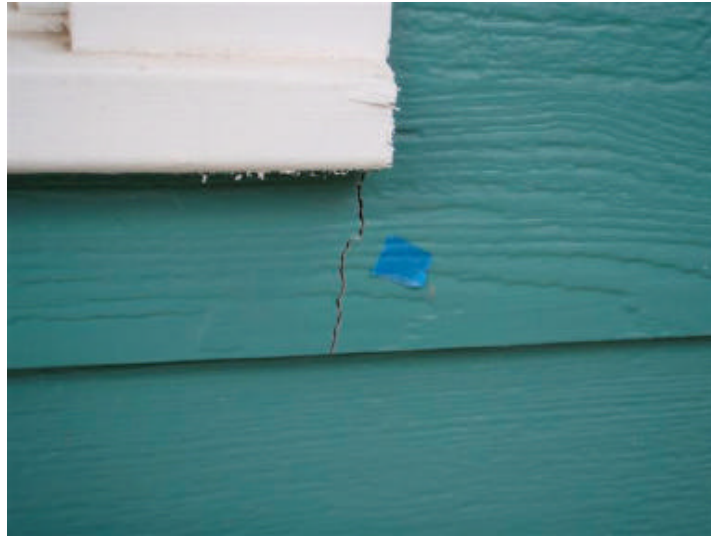
Cracked siding observed at back porch/patio.

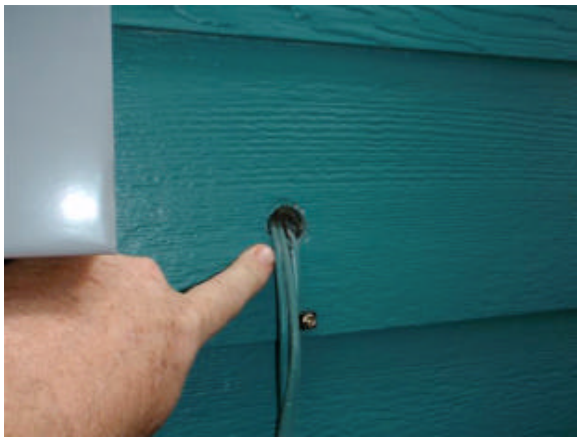
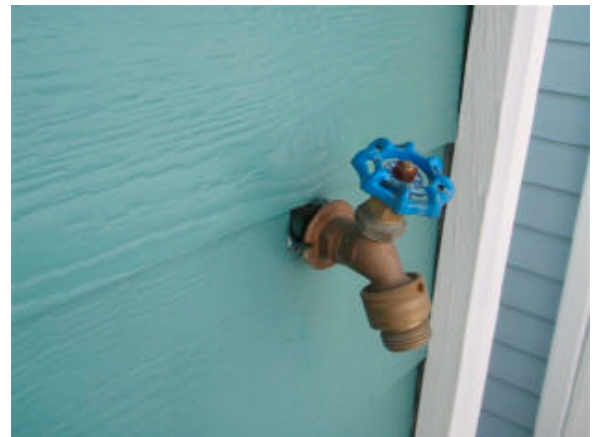
Need sealing / caulking around all holes and exterior siding penetrations on top and both sides, (leave bottom open) to prevent water entry. Including but not limited to dryer, bath and range top vents, light fixtures, etc.

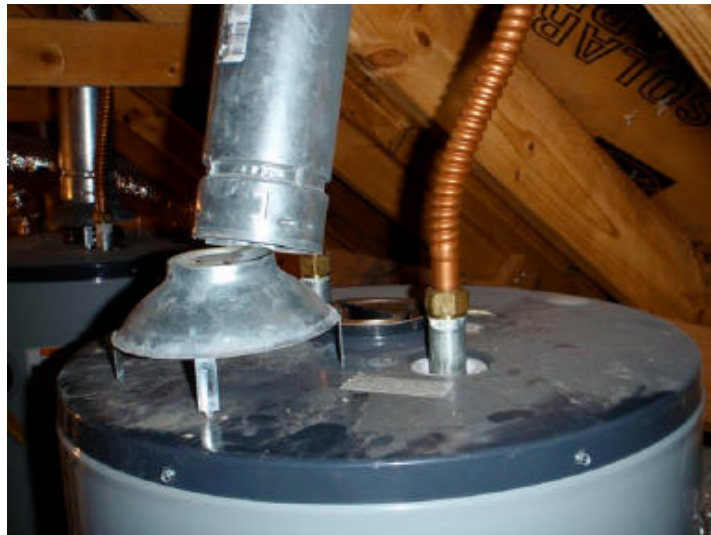
Improperly vented, vent pipe not properly aligned at top of water heater allowing products of combustion (bad gas) to vent into house/attic.

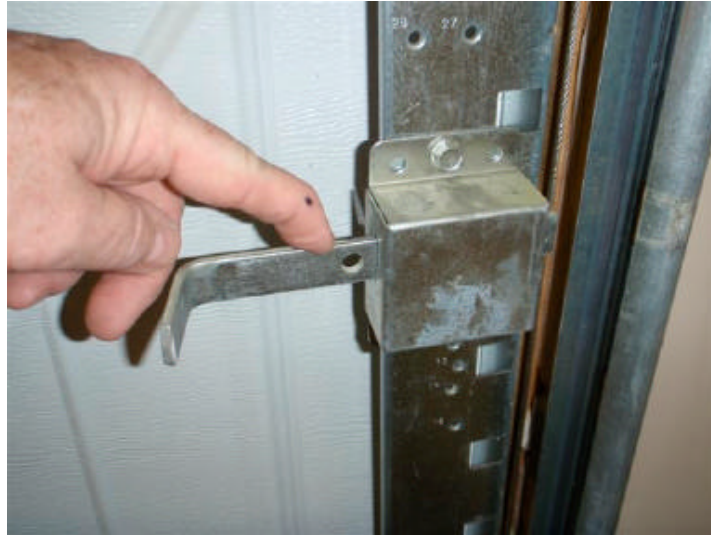
Locks should be made non-operational on garage doors equipped with openers.
